SAFETY ALERT

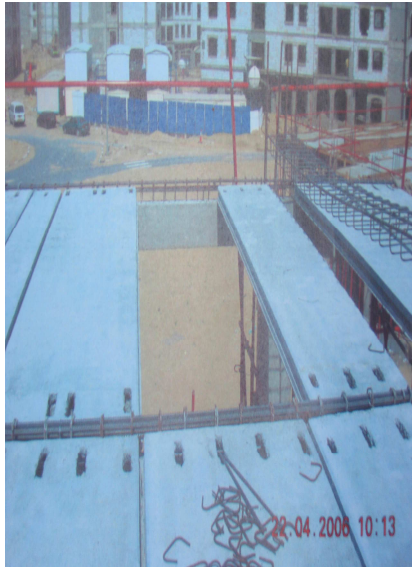
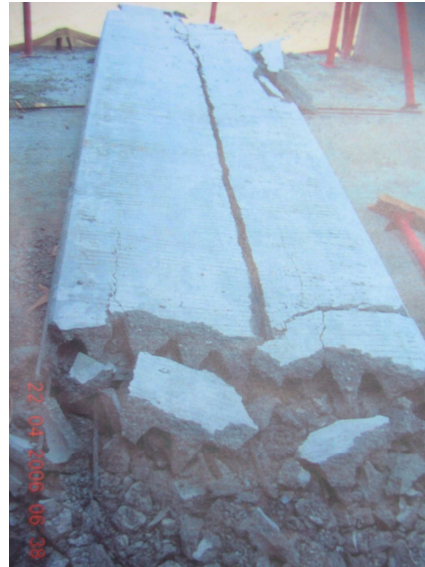
An accident occurred recently where a worker escaped serious injury following the collapse of a pre-cast concrete floor slab. The pre-cast concrete slab had been placed using a crane and the lifting strops had been removed. As the worker attempted to position the slab it slipped from its bearing and fell taking the worker with it.

Investigation by EHS identified that the concrete slab was not placed squarely on its bearing which was critical as the bearing each end was only 30mm. The lifting strops were removed before the concrete slab was in its final position resulting in the concrete floor slab twisting and falling. None of the workers involved in the operation were provided with safety harnesses.

- ➔ *Work of this nature where cranes are used to lift and position heavy items must be properly planned. A detailed risk assessment and method statement must be prepared by a suitably experienced person.*

- ➔ *All persons involved in such work must be briefed on the safe system of work, this can be in the form of a tool box talk.*
- ➔ *The load must never be disconnected from the crane until it is adequately supported and stabilised where necessary.*

- ➔ *Work on a leading edge where it is not possible to provide edge protection requires extra attention. Harnesses must be used and fixed back to a secure point.*

- ➔ *Supervisors must oversee high risk works carefully and ensure that workers follow the safe system of work identified in the risk assessment and method statement.*

- ➔ *In the case of pre-cast concrete floor slabs temporary supports should be considered until the slabs are tied and concreted in place.*
