SAFETY ALERT

A serious accident occurred recently at Palm Jumeirah where a worker fell over 8 metres to the ground whilst installing the roof GRC from the external scaffolds.

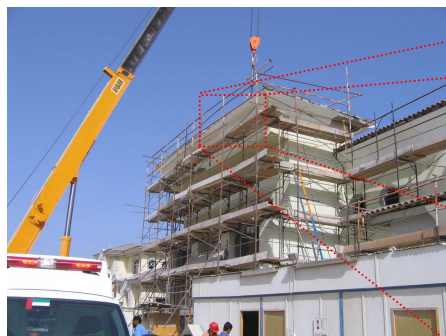
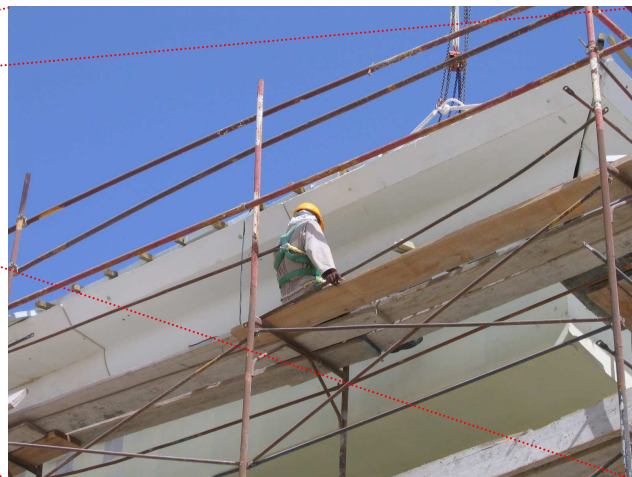
- The worker sat on the work platform and leaned backwards falling off through the gap between the top guard rail and work platform.
- The supervisor failed to ensure the middle guard rail and toe board was in place to safeguard the worker when carrying out work on the external scaffolds.
- The worker wore his safety harness without anchoring the lanyard to a secure fixed point.
- The scaffold tag indicated that the weekly scaffold inspection was 3 days overdue.
- The worker did not attend any safety briefings before starting work.

- ➔ *Even after scaffolds have been inspected and deemed safe for use, they must then be inspected weekly by a competent person from the contractor to ensure there are no missing components or unsafe alterations carried out which create unsafe conditions for the workers.*

- ➔ *All work areas must be inspected and deemed safe before commencement of the works.*
- ➔ *A specific risk assessment must be prepared for work at height. The assessment should be effectively communicated to all relevant workers/ subcontractors.*

- ➔ *The supervisor is directly responsible for the safety of those workers under his control. He must ensure that safe work practices such as anchoring of safety harnesses to a secure point are adhered to and enforce these practices.*

- ➔ *Workers must receive regular safety briefings to ensure they are reminded of the work hazards and how work is to be carried out safely.*
- ➔ *Any alterations to the scaffolds are only to be carried out by trained scaffold erectors with the supervision of the competent person.*
