Guidelines GB 9.0 – Thermal Imaging

PCFC- Entity (Business Unit) Name	:	Trakhees (Dept. of Planning & Development)
Department Name	:	Civil Engineering Department (CED)
Section Name	:	Permits (Sustainability)
Document Reference Number	:	PCFC-TRK-CED-GB-G09
Revision Number	:	01
Revision Date	:	December 2018
Classification	:	Public

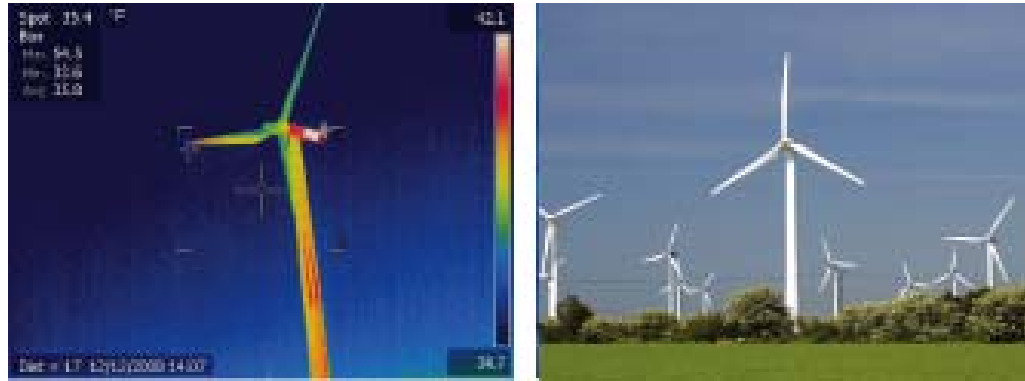
Thermal Imaging being carried out on Wind turbines

Thermal Imaging being carried out on solar panel and on wind turbines are depicted in the illustrations below

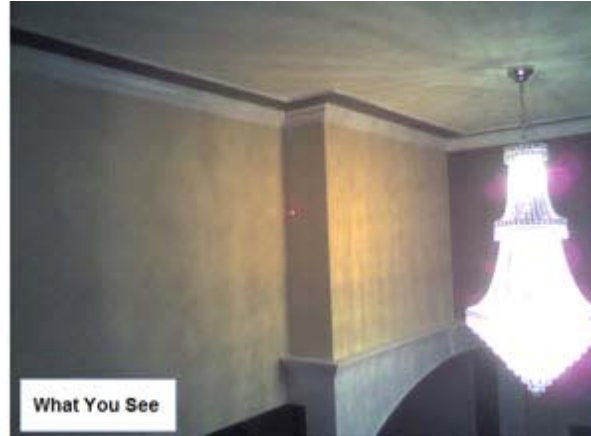
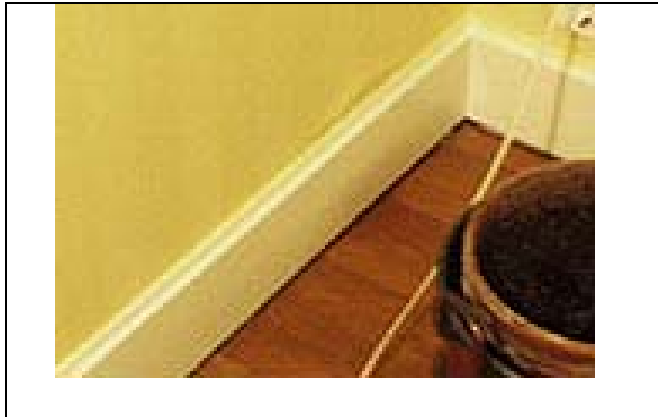
Detection and visualization of Infiltration / Exfiltration. Air leakage through the gap between the wall and the floor.

<p><i>Water Behind the wall not visible to the naked eye</i></p>	<p><i>Water Behind the wall that has been captured by the IR camera.</i></p>

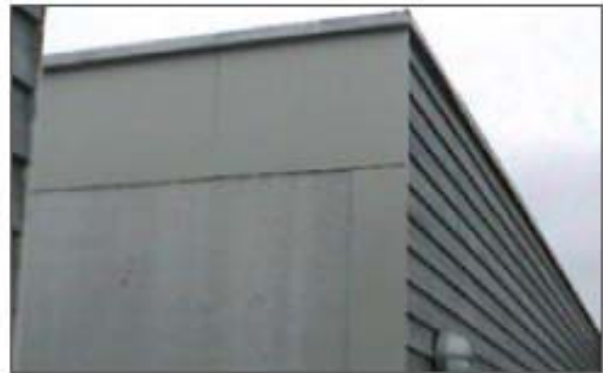
This building is warmer on the inside. It is a sandwich construction, concrete - insulation - concrete. One section of insulation is missing which is not possible to see visually either from the inside or the outside. Here thermal imaging can see what the human eye can't.

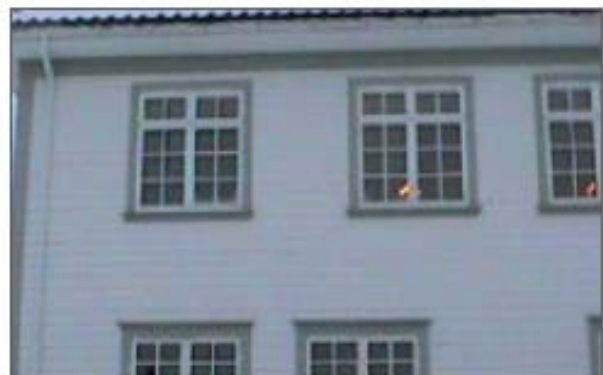
Framework construction. Many of the sections are missing insulation as indicated by the warmer colors.

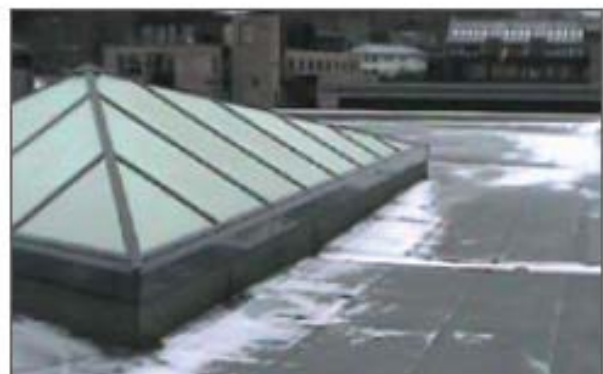
Glass roof above an atrium. It is watertight, but not air tight. Warm air escapes because of the over pressure. The solution is to air tighten the glass roof.

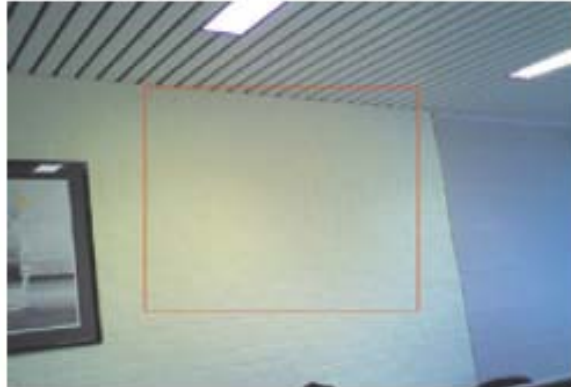
Missing insulation in parts of the wall.

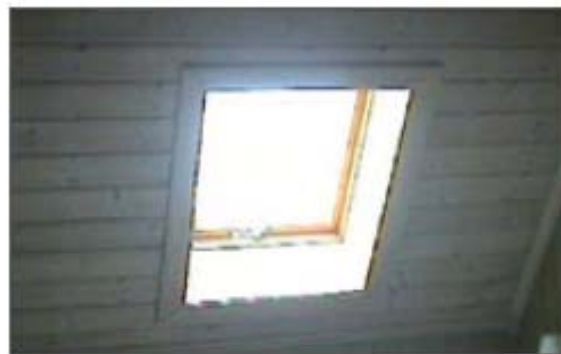
Image shows air leaks between the ceiling and the window.
