SAFETY ALERT

Safety Alert 006 311205

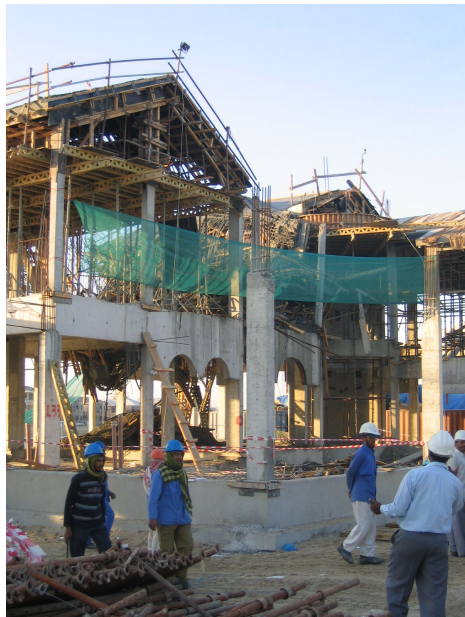
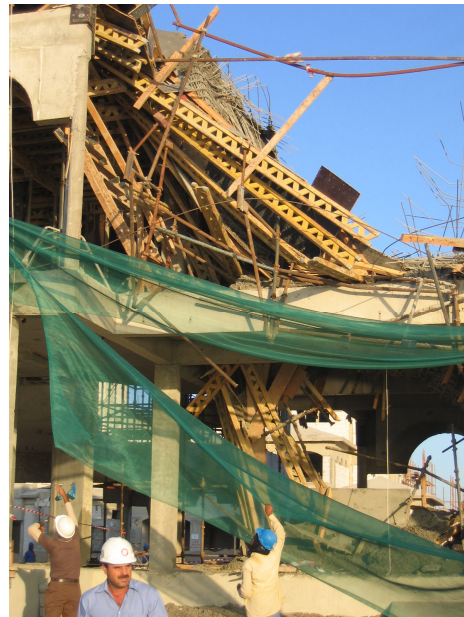
A serious incident occurred recently on Palm Jumeirah when a section of falsework on a villa collapsed during the placing of concrete. Fortunately no persons were injured but the incident had the potential to be a lot more serious.

Investigation by EHS identified that the failure occurred as a result of a combination of poor materials and insufficient propping. It was also identified that there was no adequate design in place for the falsework. Although engineering checks were carried out these checks could not be made against a workshop drawing as one was not available for the section of falsework that collapsed.

All contractors must take note of the following points and immediately review their operations involving concrete falsework.

The following must be adhered to:-

- ➔ *A design must be carried out for all significant falsework requirements and workshop drawings must be prepared.*
- ➔ *The erection of falsework must be carried out by trained and competent workers as per the specification identified in the workshop drawing.*
- ➔ *Those checking falsework designs must be in possession of the workshop drawings and must check against these drawings.*
- ➔ *Materials must be checked prior to each use in accordance with the manufacturers recommendations.*
- ➔ *Final checks must be made prior to loading falsework and a 'Permit To Load' must be in operation.*
- ➔ *All props must have the manufacturers pin fitted, short lengths of rebar must not be used as pins under any circumstances.*
- ➔ *Different falsework systems should not be mixed as this invalidates the design and there could be incompatibility between systems.*
