SAFETY ALERT

Safety Alert 023 220806

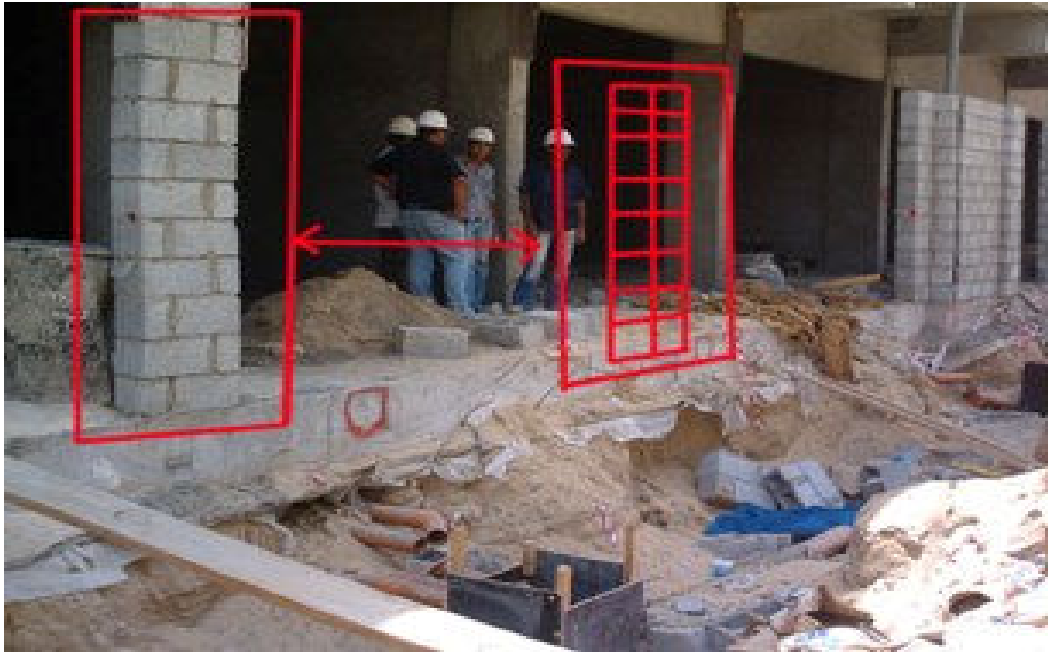
A worker was seriously injured when a free standing blockwork wall collapsed when he placed a ladder against it to fix shuttering for a lintel. The worker then fell onto 5mm rebar that was being prepared for a man hole cover in the excavation below. The worker fell 1.5m and the rebar penetrated the workers body. The worker was evacuated to the hospital.

Investigation of the accident by EHS identified that the contractor had failed to identify the free standing wall as a hazard and failed to provide the correct access equipment to carry out the work safely. The risks associated with vertical rebar had also not been adequately controlled.

- ➔ *All contractors must undertake risk assessments for their works and identify the protective and preventative measures that must be in place to allow work to be carried out safely.*
- ➔ *In the absence of planning workers will try to improvise to get the job done. Contractors must plan works carefully and ensure that any additional equipment needed to get the job done safely is provided.*
- ➔ *A ladder is always the last resort as a place of work, there is no substitute for a safe working platform.*
- ➔ *Ends of Rebar are a danger and must be protected to prevent cuts and penetrative injury. Plastic caps are available at little cost and are reusable.*
- ➔ *Walls should be supported temporarily until the lintels are bedded in place.*
