SAFETY ALERT

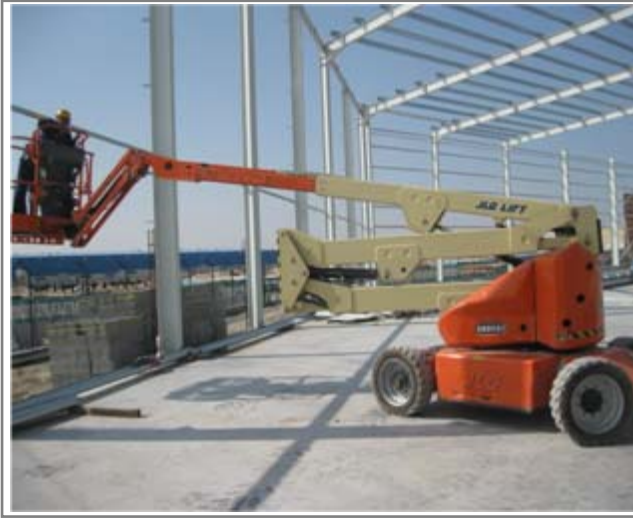
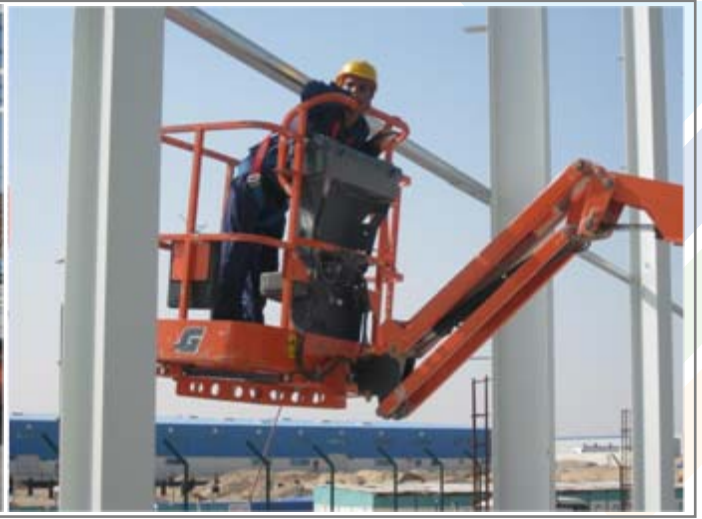
Recently at Jebel Ali Free Zone (South), a worker got trapped between the purlin and the bucket of Mobile Elevated Work Platform (MEWP) that he was operating. The victim was trying to remove and transfer the lifeline to another location, when he lost control of this equipment.

Investigations by EHS revealed that the victim was not authorised to operate the MEWP (he was without third party competency certificate). He operated the equipment during break time without the knowledge of his Foreman / Supervisor.

Risk Assessment for the use of MEWP was not available. Risks & hazards of its use was not communicated to the workers through Tool Box Talks. The equipment was not locked during the break hours.

The following minimum requirements must be adhered to:-

- *Risk Assessments for the use and operation of MEWPs must be available, and communicated to concerned workers.*
- *Only authorised and competent persons (with third party competency certificates) are allowed to operate the MEWP.*
- *Ensure that the MEWP is kept under lock & key when it is not in use to avoid unauthorised operation.*
- *Ensure that the MEWP is in good working condition and with valid (third party) Test Certificate.*
- *Record of Tool box talks to all personnel involved in MEWP operations should be available. Proper use of personal protective equipments should be practiced.*
- *Work must be carried out under the supervision of competent persons.*
- *Emergency Response procedures must be available, communicated and followed.*
